Intel® E8501 Chipset North Bridge (NB)

Specification Update

May 2006

Document Number: 309622-001

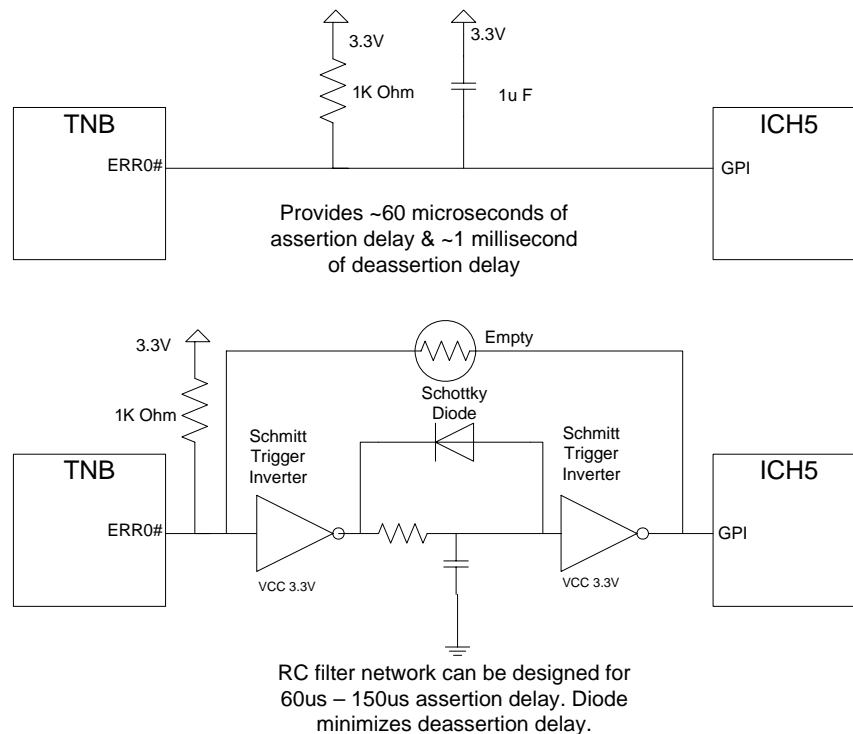
20. SMI Escalation via ERR[2:0]# Pins May Result in IERR#

Problem: Any condition routed to MCH ERR[2:0]# output pins for SMI# escalation that would result in data poisoning on FSB will result in a CPU IERR# assertion due to race condition. The race condition exists between poisoned data presented to the FSB by the MCH and the uncorrectable error escalated to SMI# via ERR[2:0]# pins. If the CPU observes an SMI# assertion before the poisoned data is presented to the FSB, the CPU asserts MCERR# followed by IERR#. The CPU expects the SMI# assertion to occur at least 10 BCLKs after the associated MCERR# assertion. Conditions that result in data poisoning on FSB are uncorrectable memory ECC errors or poisoned TLPs received from any PCI Express* port.

Implication: CPU may assert IERR# and cause a system hang before the error may be logged in SMM.

Workaround: The following workarounds have been identified:

1. Log errors upon reboot
 - System components (TNB, CPU, Southbridge) preserve errors across warm resets via sticky error registers
 - Requires a mechanism to reset system upon IERR# (server management controller, depress system reset button, etc.)
2. Delay SMI# assertion by inserting a 60µs-150µs delay on the ERR0# pin
 - Two recommended circuit solutions (other solutions may be possible):

- Route errors that result in FSB data poisoning to the ERR0# pin (IO4, M2, M4-13, M15)
3. Disable FSB data parity (ECC on Potomac/Tulsa) checking on CPU
 - Prevents CPU from asserting MCERR# on poisoned data

Note: As in all cases, error-logging on reboot is required.
